Cooling Systems

For Automotive Conversions

By: Hans Mayer.

Part 3

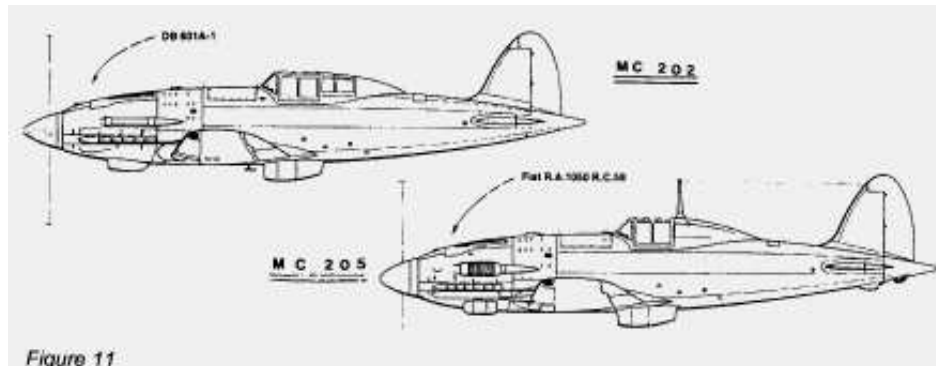
The third example is the Macchi MC.202 and MC.205. Figure 11 shows in the side view, the radiator well back under the fuselage, but ahead of the wing trailing edge. Right in the high pressure area of the wing. This is where a radiator or air intake should be located for top performance. The oil cooler is well out of the propeller pulses. With that clean cooling system, the radiator could be kept small and lightweight. This aircraft had no cooling problems and worked very well, even in Sicily. Some wiseguy wanted to move the radiator under the chin, to prove a point. Which he did, (Fig. 12) the engine over-heated in simulated dogfights and the aircraft lost in climb and top speed performance.

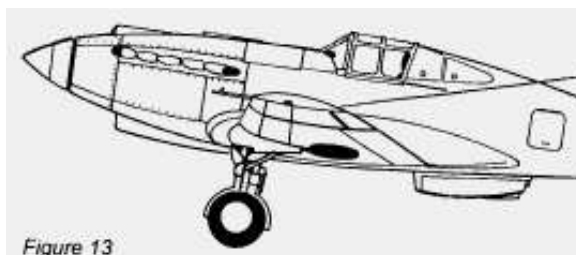
Figure 13

Example No. 4 is the Curtiss P 40. The XP-40 had the radiator right in the high pressure area under the wing, located where it belongs. Fig. 13 shows this neat and clean installation, a good, low drag cooling system.

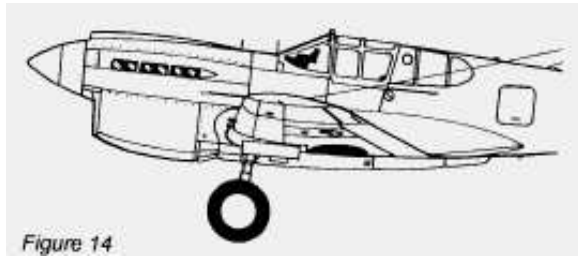
Figure 14

Then they moved the radiator under the chin. The penalty was a larger unit, with high drag, that screwed up the airflow behind that big housing. This radiator was marginal and when the Allison V-1710-39 with 1150 HP was installed on the D-Model, things got really huge and ugly. The designer had initially gone to great pains to keep the flow around the airframe clean, with large fillets on the wingroot and the tail, only to have the airflow screwed up with that monster of a radiator housing (Fig. 14).

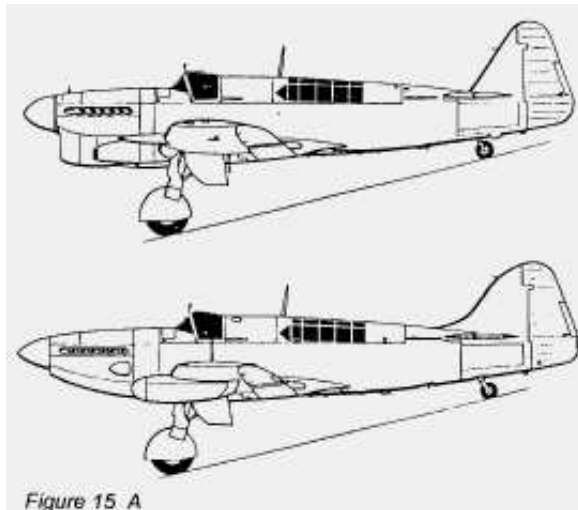
Figure 15 A

The Fairey Firefly is another example. The Mk1 with the 1735 HP Rolls Royce Griffon II B engine had a chin cooler. Figure 15A has all the details of this crappy and ugly installation.

When the Griffon 74 with 2,245 HP became available, the chin cooler could not handle the cooling and the radiators got tucked away in the wing. Look at that clean engine cowling (Figure 15A bottom illustration), after the cooling was done right!

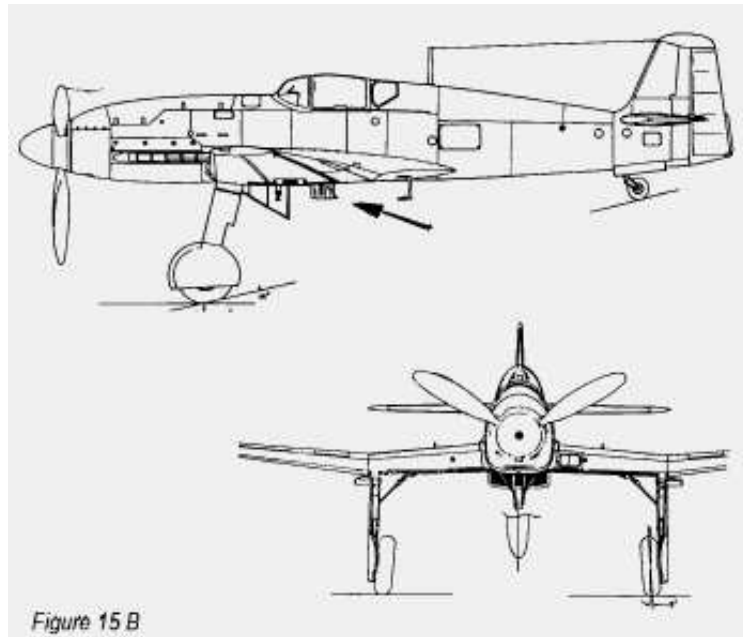
The Heinkel HE100 is example No. 6. In Fig. 15B you can hardly make out the short radiator under the wing.

Only the front view shows the housing clearly. This cooling system could handle the 1,020 HP of the DB-601A with capacity to spare. Now go back to the 109B and look at the huge sharkmouth that was needed to handle 340 HP less! Just because the radiator was in the wrong location.
